## Executive Summary

Over the 2016 summer break, Greystone West performed site inspections at the six campuses within the Shoreline Unified School District to assess the condition of the sites following the modernization work of the early 2000's. The study focused on exterior skin in response to the harsh climate in which the District resides. Roof Inspections were also conducted at all sites and recommendations were made ranging from minor maintenance to full replacement. These costs include gutters and flashings integral to the roofs.

Roof Assessment Summary

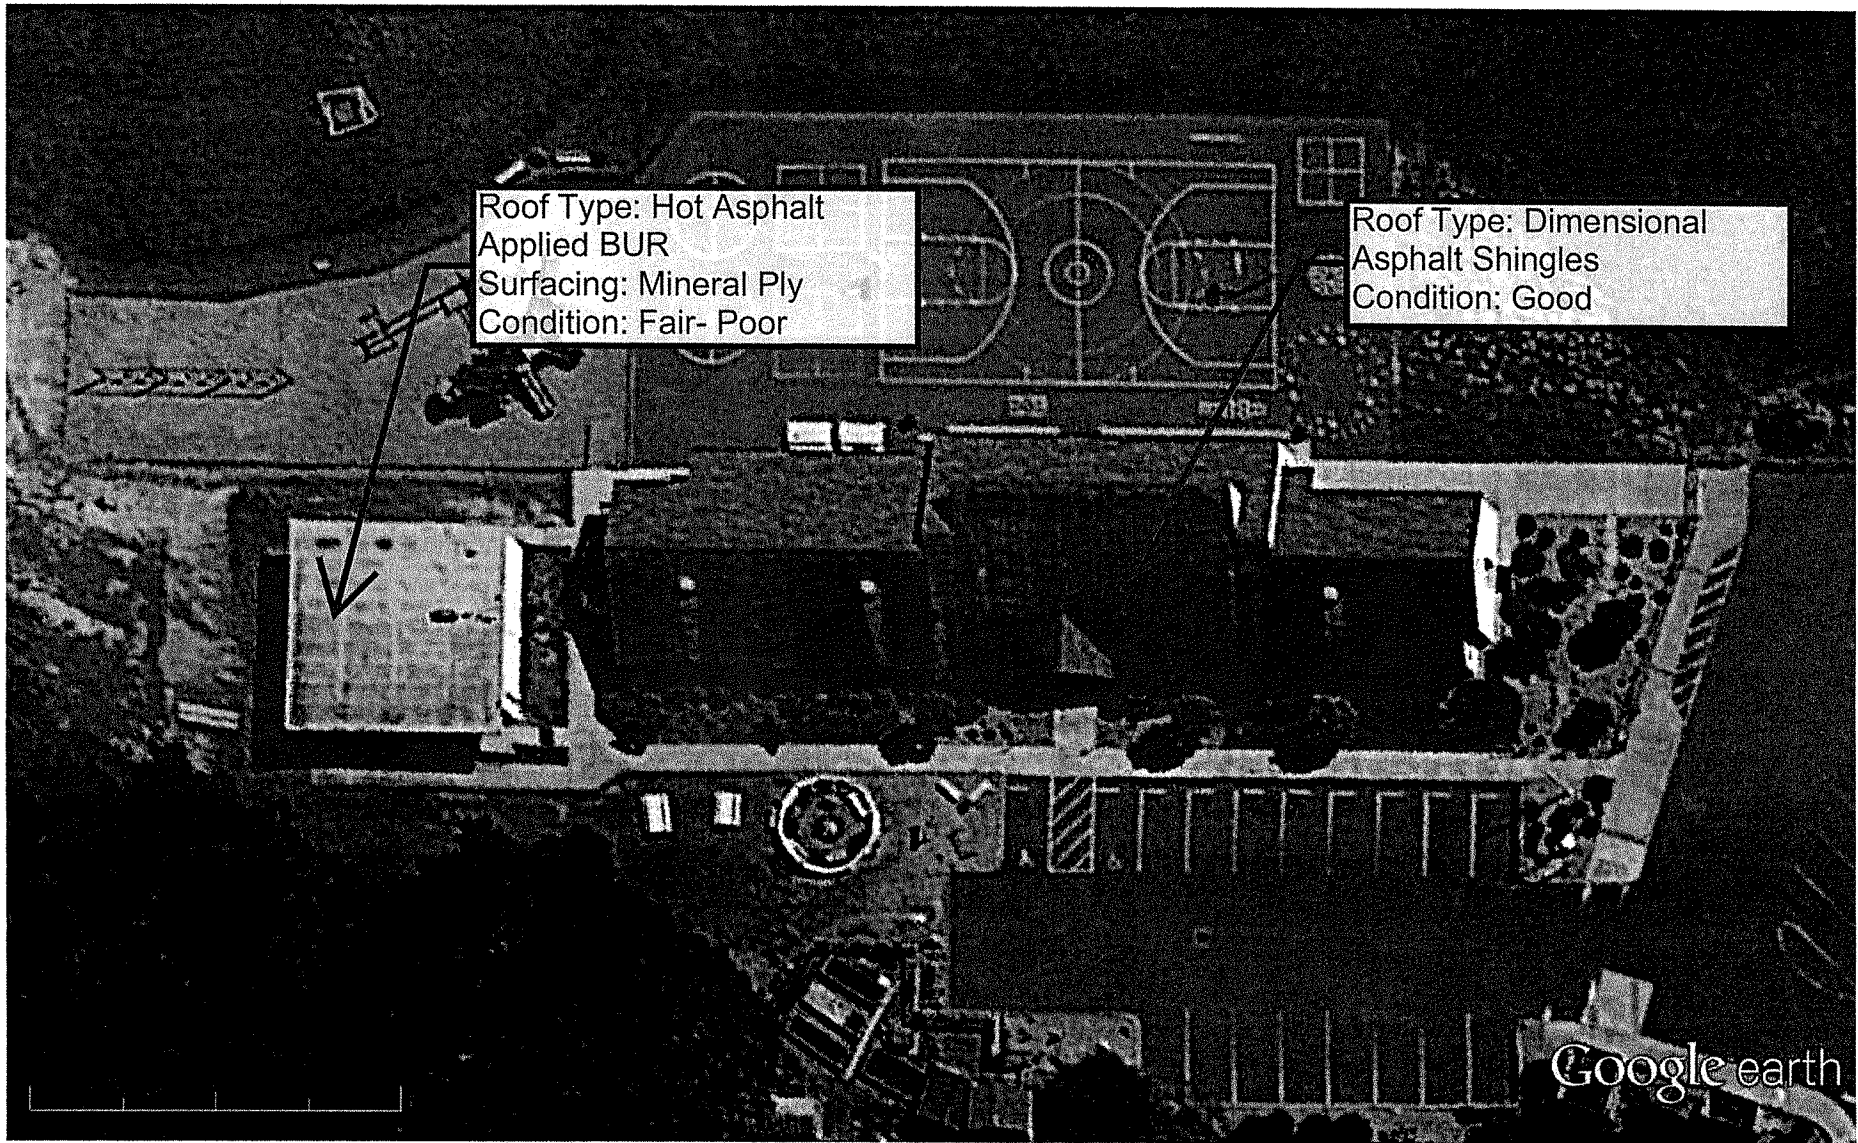
Roof Type: Hot Asphalt  
Applied BUR  
Surfacing: Mineral Ply  
Condition: Fair- Poor

Roof Type: Dimensional  
Asphalt Shingles  
Condition: Good

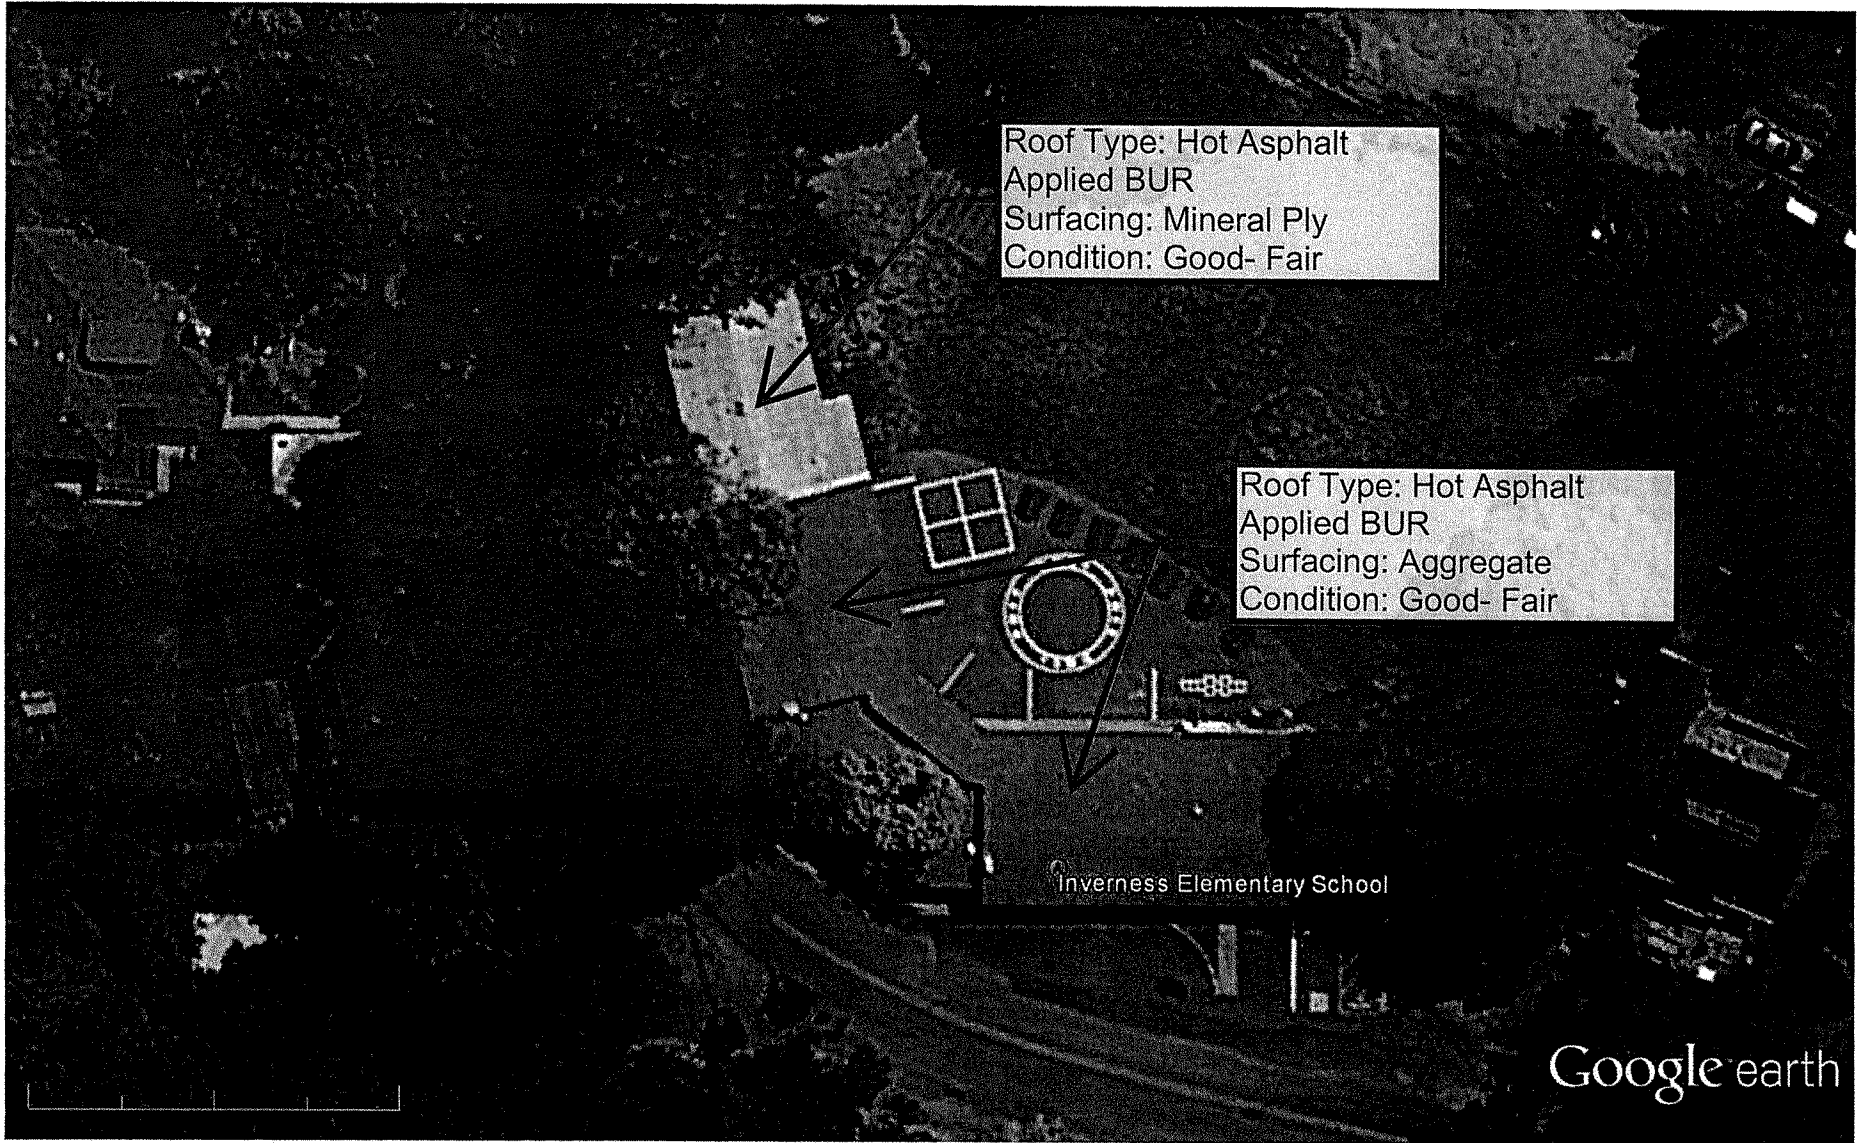
Inverness Elementary School

Roof Type: Hot Asphalt  
Applied BUR  
Surfacing: Mineral Ply  
Condition: Good- Fair

Roof Type: Hot Asphalt  
Applied BUR  
Surfacing: Aggregate  
Condition: Good- Fair
